Report 7440-13-FBC

TESTING OF SAFTY RAILING

General: Load tests on Aluminum / PCV Plastic Safety Railings to show conformance to requirements the Florida Building Code, FBC-2010.

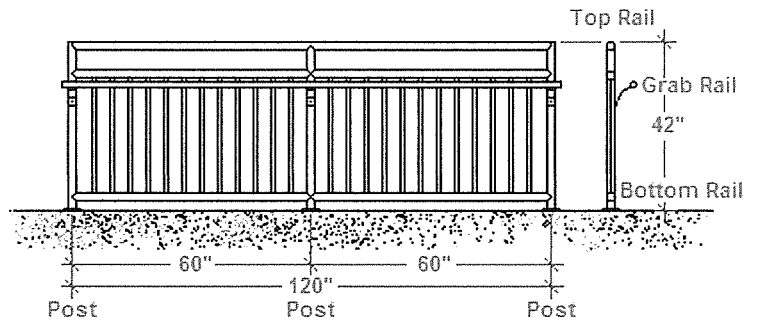
Description of Specimen: The test specimen consisted of a composite structure of PVC pipe and aluminum pipe as shown in the below referenced drawings. The test specimen was also of the nominal dimensions as shown at right (as viewed from interior side, all diagrams are similar).

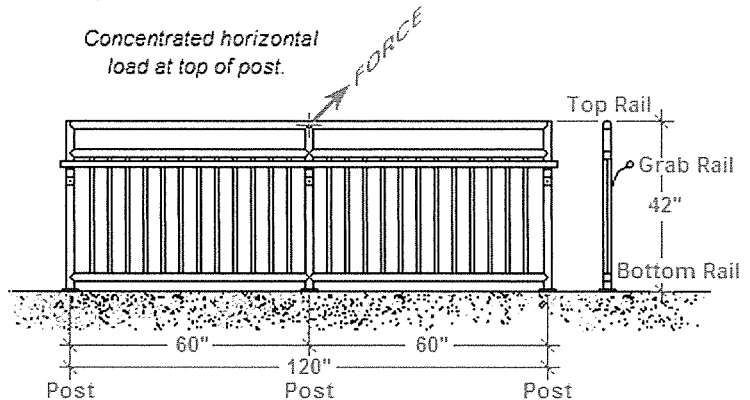
Tests upon Posts

Concentrated horizontal load at top of post.

Test IV – Horizontal Point Load on Post:

A single load was applied, for sixty seconds, to the top of the central post of the specimen (as shown in the diagram at right). Deflection Gauges were placed at the top of this post to record deflections. Gauges were zeroed before each subsequent load. Results as follows:
